**BARBER DAM  
JACKSON COUNTY, MISSOURI  
MO 20570**

**PHASE 1 INSPECTION REPORT  
NATIONAL DAM SAFETY PROGRAM**

**PREPARED BY: U.S. ARMY ENGINEER DISTRICT, ST. LOUIS**

**DECEMBER 1960**

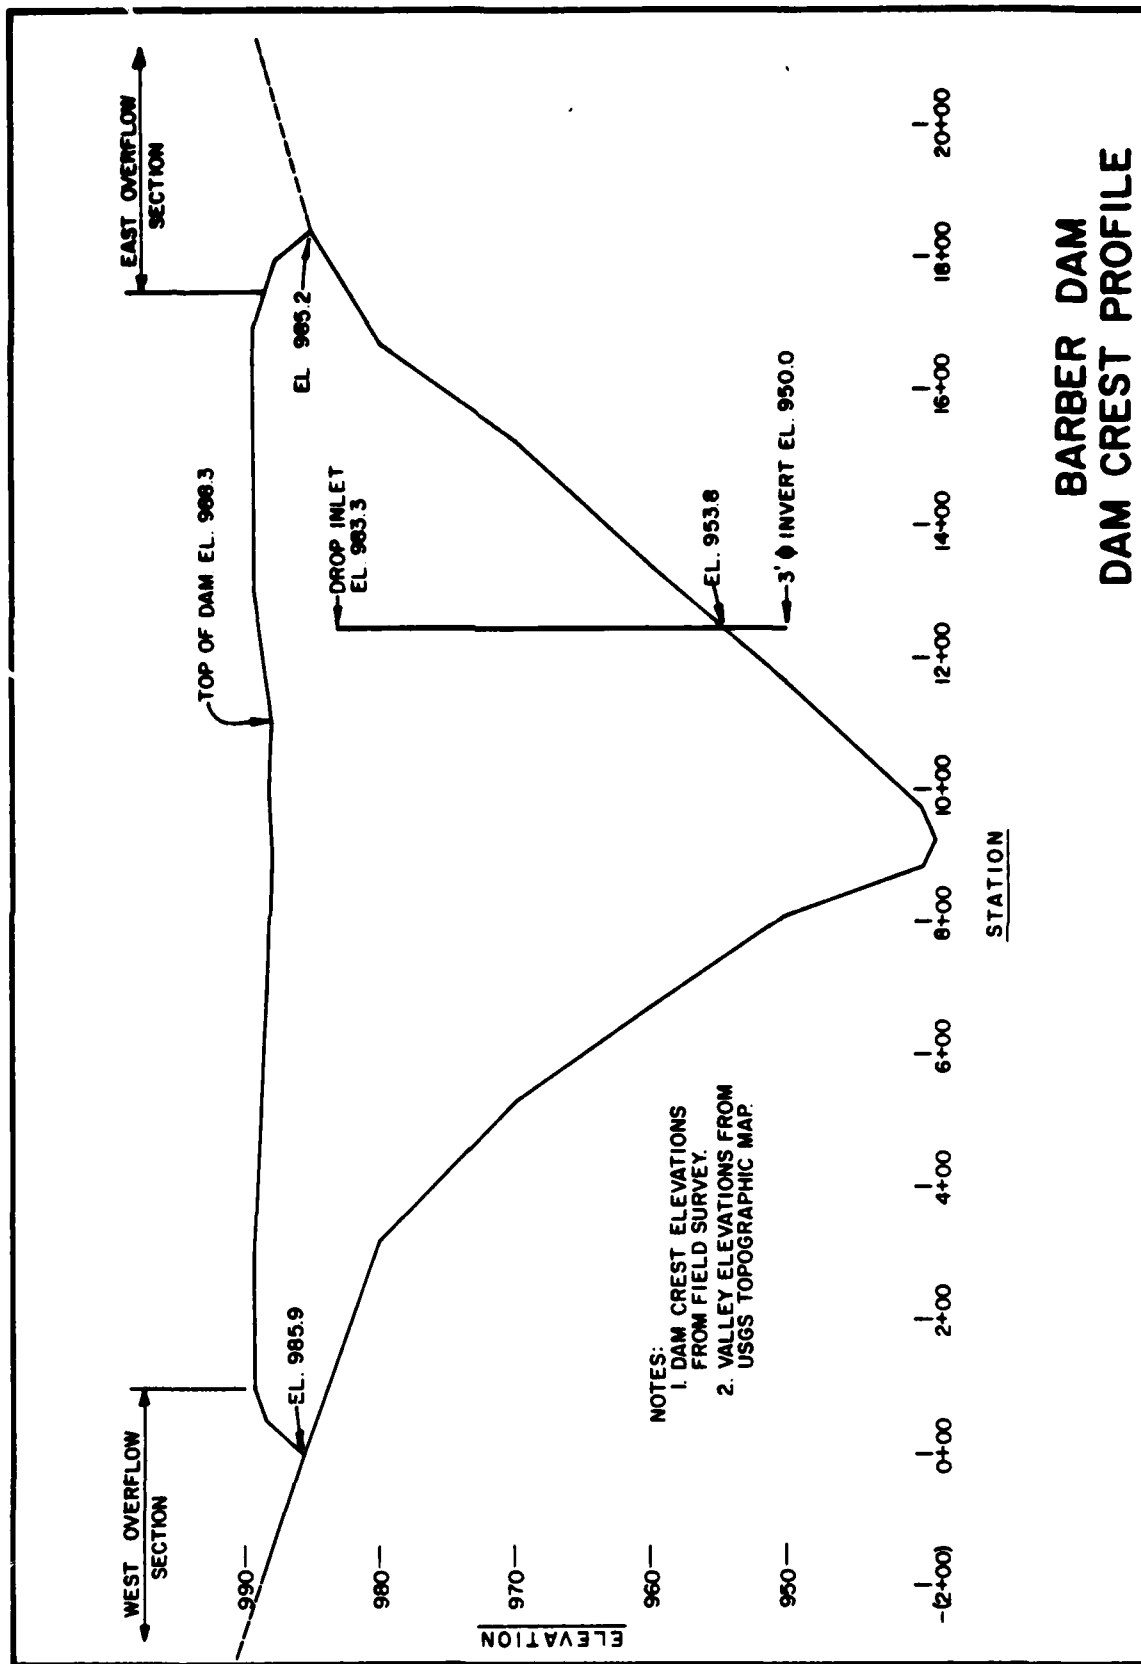
**BARBER DAM  
DAM CREST PROFILE**

The low area surveyed on the dam crest at about station 11+00 appears to be in proximity of the original stream channel and could possibly be indicative of embankment material consolidation or consolidation of the underlying foundation materials. This is not believed to be a significant problem at this time, however, the dam crest should be monitored on a regular basis and if further lowering of the crest is observed it should be evaluated by an engineer experienced in earth structures.

(8) The observed settlement of the dam crest should be monitored on a regular basis to ascertain whether or not it is an ongoing condition. If the condition is found to be continuing, corrective measures should be developed by an engineer experienced in earth dams and implemented.

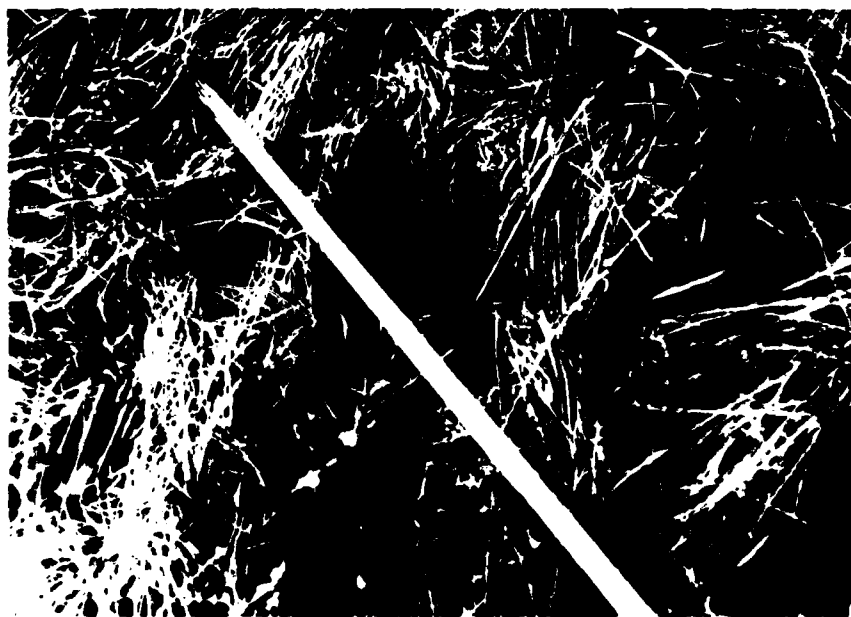
Burrowing animals will continue to damage the embankment if a program is not undertaken to eliminate them. Piping failure of embankments have resulted from damages caused by burrowing animals.

PHOTO 12: ANIMAL BURROW ON DOWNSTREAM FACE OF DAM

(6) The animal burrows in the embankment should be corrected since they can contribute to the occurrence of piping. Control measures should be implemented to discourage animal activity in the area. The embankment slope should be monitored by a qualified engineer during repair of the embankment.
